## **TECHNICAL INFORMATION LETTER**

### **LUBE OIL VARNISHING**

This TIL applies to all heavy-duty gas turbines.

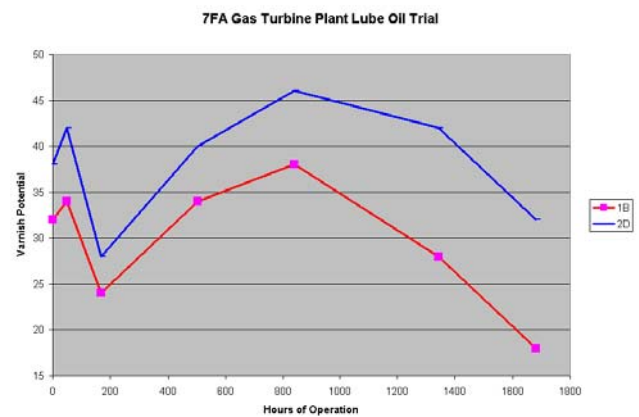
**Figure 3:** Balanced Charge Agglomeration Validation test

GE has performed extensive studies to validate the use of Balanced Charge Agglomeration technology. A recent test on seven 7FA+e turbines with this technology installed was run for 75 days while performing routine colorimetric sampling. The results of this test can be seen in Figure 3. Note that the results for two turbines are shown. The other five have been removed for clarity. All turbines exhibited similar results.

It should be noted that an initial downward trend is realized during the clean up phase followed by and upward trend as varnish that had been plated out on the system surfaces becomes reabsorbed into the oil. Over time, this varnish bloom will drop back down to desirable levels as the reclamation unit remains in service, leaving the oil system's surfaces and turbine oil clean.

This technology can be used either to mitigate a current varnishing issue or to prevent the occurrence of it.

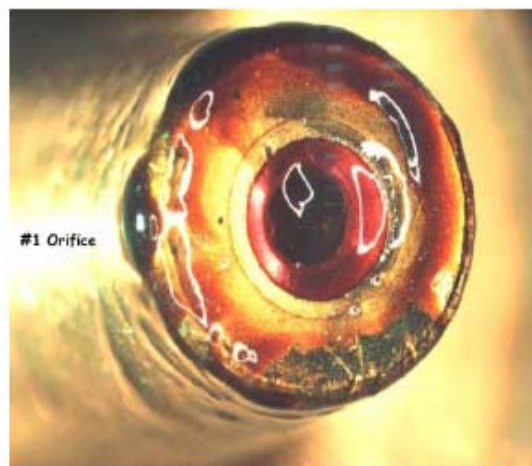
图 1： 伺服阀口的油泥

通常情况下，胶质物不能延长寿命，而是严重损害了设备利用性及可靠性，胶质物很容易在液压系统的低流量、小通道中积聚沉淀，特别是伺服阀等精密部件，一旦产生胶质物会使伺服阀动作缓慢，无法正常动作，引发设备故障

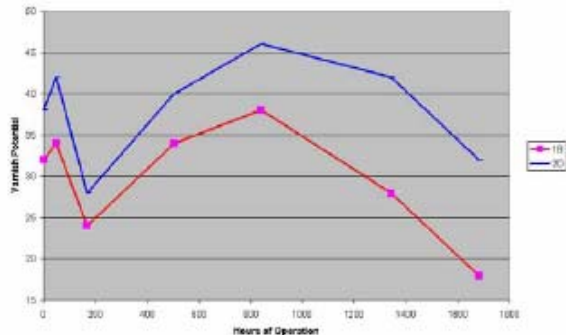
图 3: 平衡电荷净化技术有效性试验

GE 公司做了全面的试验证实了平衡电荷净化技术的有效性。试验在 7 台 7FA+e 型燃气轮机上使用了 BCA 这项技术，运行 75 天，同时进行常规色度测试。试验结果请见图 3，注意：图上只显示了 2 台机组曲线，另 5 台机组曲线被拿掉以便图形显示的更清楚。所有 7 台燃气轮机的结果大致相同。

注意最初净化阶段曲线向下，随后曲线又向上是因为设备表面的胶质物被清除掉，暂时回到油中，随着设备在线净化的时间推移，胶质物曲线开始降回到理想的程度，表明润滑系统表面以及透平油本身均变的洁净如新。

平衡电荷净化技术既可以改善已有的胶质物问题，也可以防止胶质物形成。
